# Manhole Inspection Summary

Manhole # S19CC1008MH

Insp Date: **3/13/07 10:03 AM**

**Location** Address: **3635 KEYSTONE AVE**

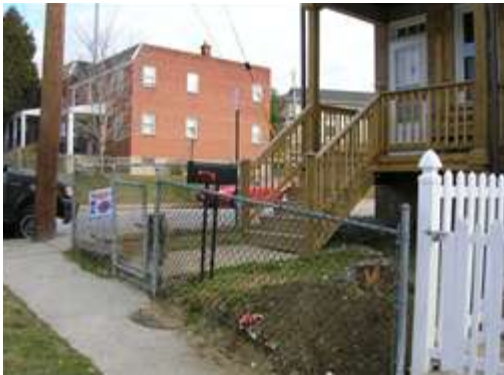
Location View

Comments **Lid partially buried and obstructed by fence, see photos. OPENED AND INSPECTED 5/7**

1st visit.

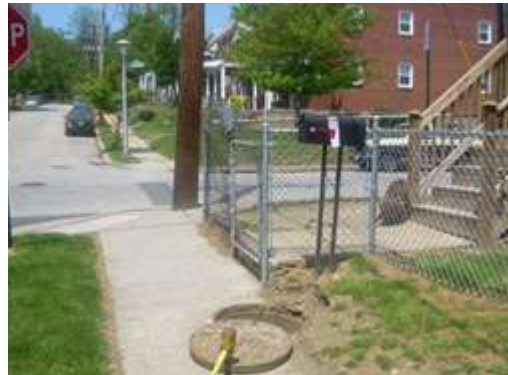
Location View

2nd visit - fence alteration.

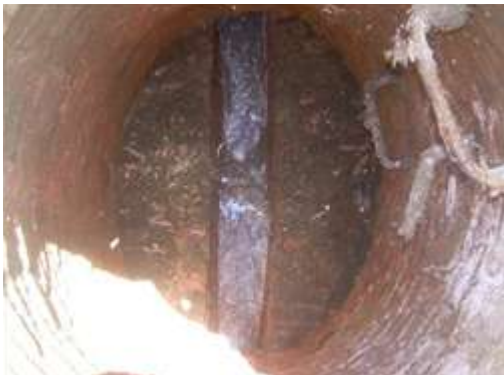
Top View

**Bench** ☒ Exists Material: **Brick** ☐ Parged ☒ **Debris** (not Condition related)

**Channel** Material: **Brick** ☐ Parged ☒ **Debris** (not Condition related)

**Steps** Count: **3** Missing: **1** ☒ **Corroded**

**Surcharge** ☒ **Evidence Of Surcharge** Depth: **1.5** (ft.) ☐ Active Surcharge Present

Corroded and missing steps. Evidence of surcharge - Bench debris. Channel debris.

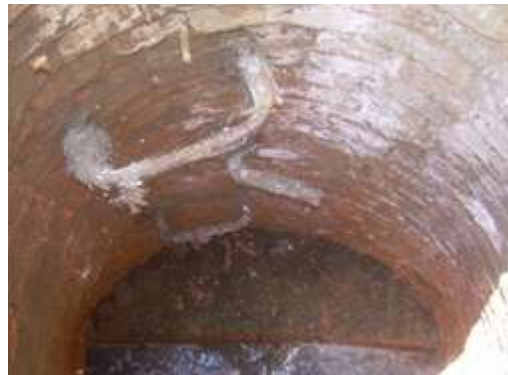
Defect

Infiltration: ☐ None ☐ Joint ☐ Cracks ☐ Mortar ☐ Roots ☒ **Wall**

Infiltration: ☐ None ☐ Joint ☐ Cracks ☒ **Mortar** ☐ Roots ☒ **Wall**

Corbel and Barrel infiltration.

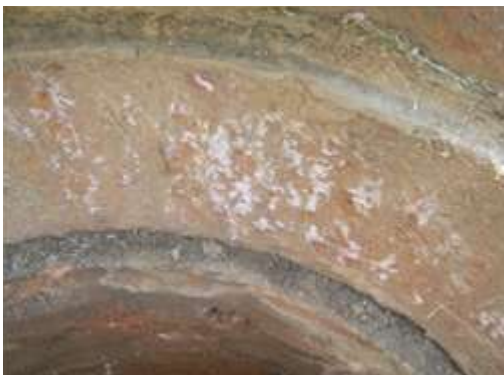
Defect

**Frame** Offset: **1** (in.) Condition: ☐ Sound ☐ Cracked ☒ **Leaks**

Condition: ☐ Sound ☐ Cracked ☐ Root Intrusion ☐ Loose Brick ☒ **Deteriorated**

Infiltration: ☐ None ☒ **Joint** ☐ Cracks ☐ Mortar ☐ Roots ☐ Wall

Frame leaks. Adjustment deterioration and infiltration.

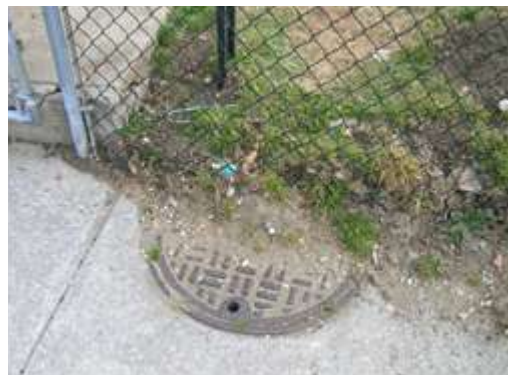
Defect

Partially buried lid - Unable to open.1st visit.

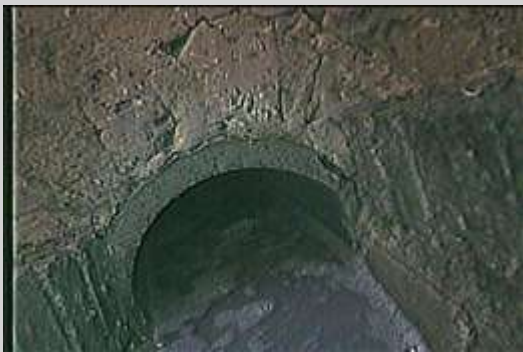
### 8 in. Circular Gravity Sewer Pipe Out @ 12 O'Clock

Barrel deterioration and infiltration.

Infiltration: **Evidence** Pipe Seal Cond: **Cracked**

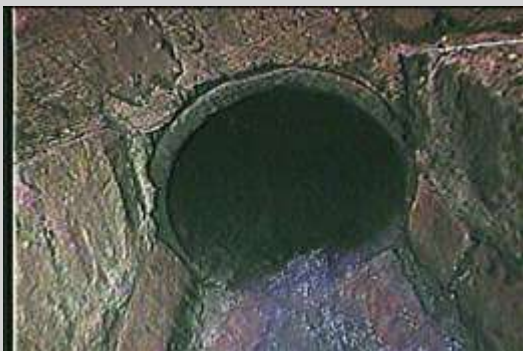
### 8 in. Circular Gravity Sewer Pipe In @ 6 O'Clock

Channel deterioration.

Infiltration: **Evidence** Pipe Seal Cond: **Cracked**
